Passive Fireproofing: The Key to Maintaining Stability

By Gourav Patodi, Brindley Engineering Reliability Engineer

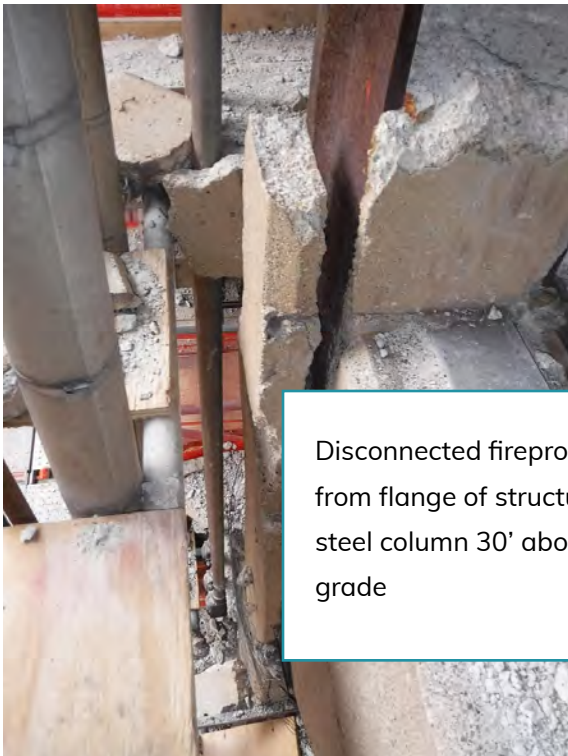
Figure 1: No Reinforcement in Fireproofing

During the construction phase of a recent repair project, when demolition of existing FP was performed, it was discovered that a major section of concrete was disconnected from the flange of the structural steel column at approx. 30 feet above grade (see Figure 1). It was further discovered during the demolition process that no mechanical anchorage or reinforcement was present around the steel member resulting in large pieces of concrete spalling (see Figure 2). Without the presence of mechanical anchorage, fireproofing relies strictly on the strength of the chemical bond to the steel, making the FP more susceptible to cracking and spalling. This bond often fails when expansive forces from corrosion of the embedded steel are introduced. For this reason, it is critical that

Disconnected fireproofing from flange of structural steel column 30' above grade

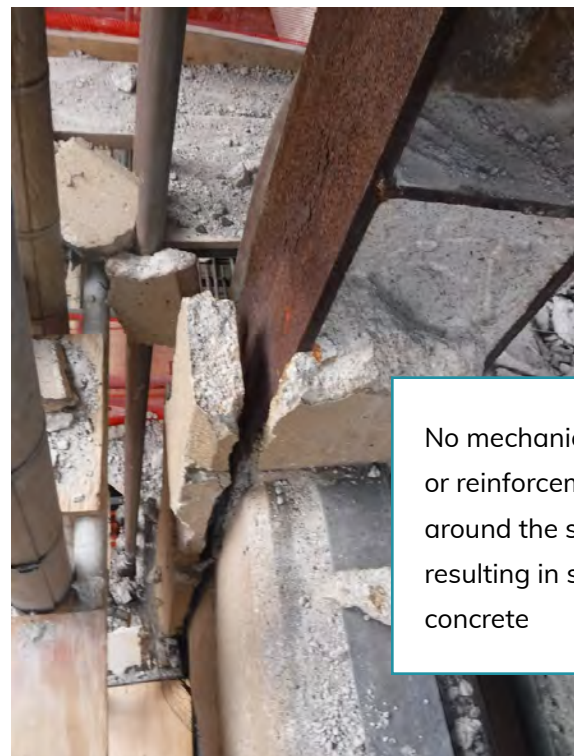
Figure 2: Concrete Spalling

No mechanical anchorage or reinforcement present around the steel member resulting in spalling of concrete

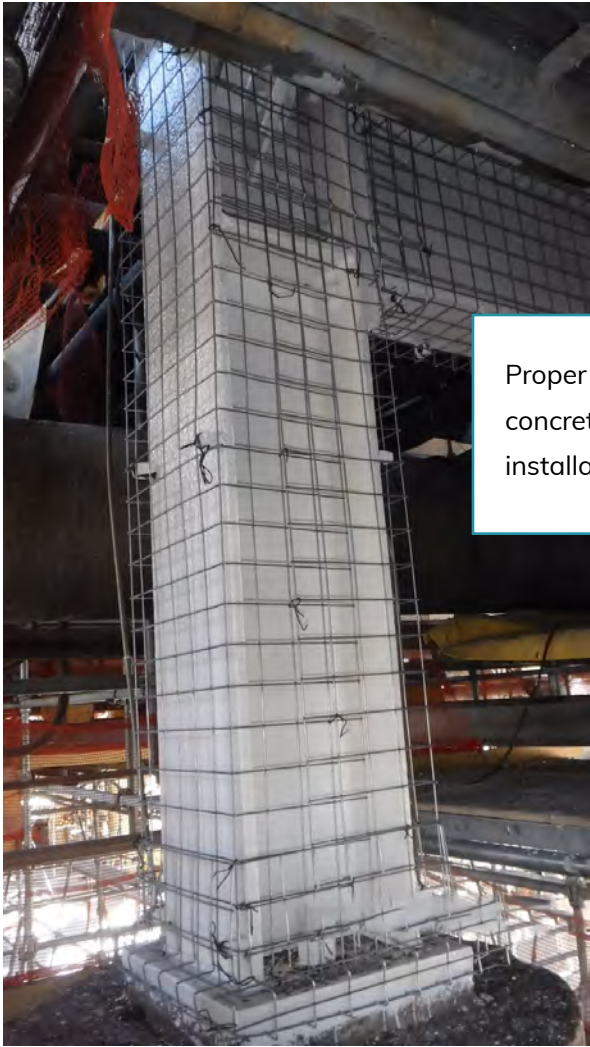
Figure 3: Proper Reinforcement

Proper reinforcement and
concrete fireproofing
installation

The fireproofing around the flanges of a steel member has greater risk of falling than the fireproofing around the web of the member due to thinner concrete cover around the flanges. Anchoring the Welded Wire Reinforcement (WWR) to the steel member with welded studs is a proven method for minimizing potential for fireproofing spalling from member flanges. For the column discussed above, anchor studs were welded to the flanges at regular intervals and WWR was tied to these anchor studs. See Figure 3 and Figure 4 for proper reinforcement and concrete fireproofing installation.

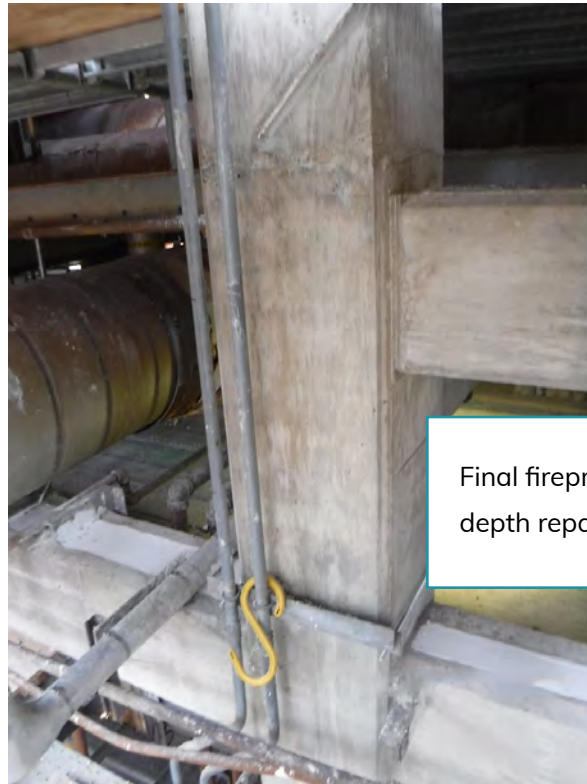
Figure 4: Final Fireproofing

Final fireproofing after full
depth repair
