## Root Cause Failure Analysis and Rehabilitation Engineering for Waste Treatment Tank

A Midwest Chemical Facility approached Brindley Engineering to determine why the roof of a concrete wastewater treatment tank was failing and to design a replacement roof and other tank repairs based on the failure assessment. Due to the criticality of the roof from a safety as well as economical perspective, the new roof had to be designed for a minimum 20-year design life.

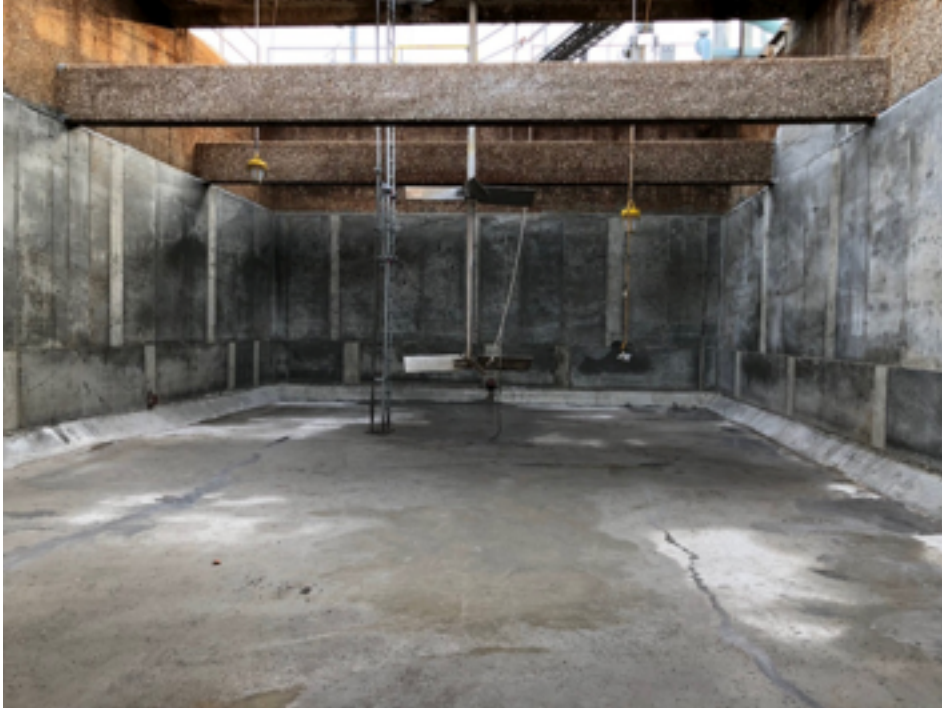
View of tank after cleaning – Ready for Inspection
