Investigate Design Build Approach to Improve Reliability of Delayed Coking Unit Chutes

A refinery in the American West had a Coking Unit that was experiencing failure of the coke chutes, a difficult and costly item to repair, and desired a more reliable and cost-effective solution. Previous solutions failed due to stresses caused by thermal shock, abrasion, and corrosion. Brindley Engineering partnered with a specialty structural repair company for a turn key, Investigate, Design, Build approach to ensure close integration to meet the technical and logistical demands of the turnaround window for repair.

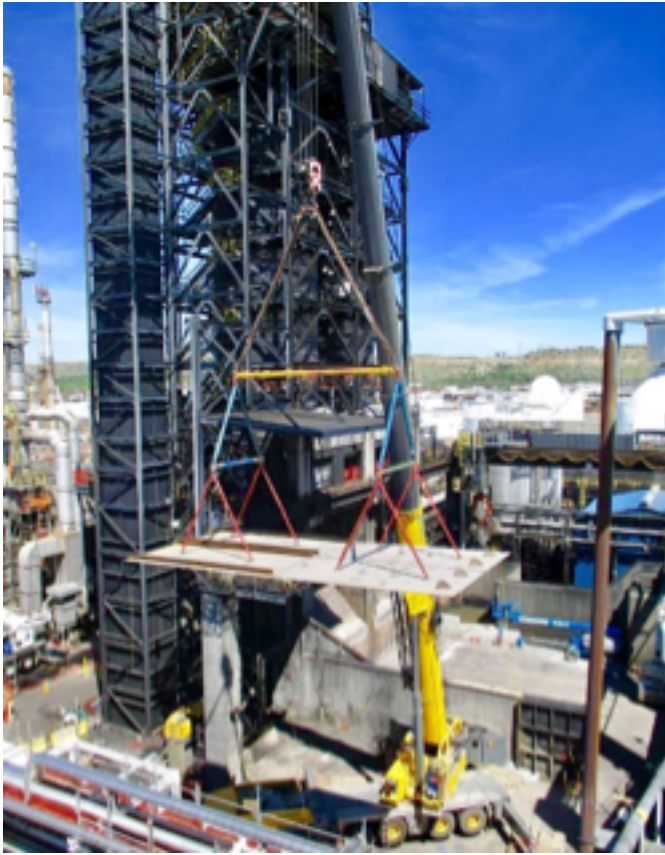
View of Wear Plate Being Lifted

We have designed and conducted follow-up inspections on similar projects in the past and have applied our long-term knowledge to best practices in the wear plate support design to ensure it meets the rigors of this highly demanding environment of high heat, sulfur, water, abrasive coke, impact loading, etc. The wear plates are very large (nominally 800 square feet) and require special welding details to prevent them from warping or having high residual stresses post fabrication. The size of the wear plates also creates significant logistical challenges to transportation and rigging. Brindley conducted a Finite Element Analysis (FEA) of the plates and lift points and developed the Engineered Lift Plan to ensure the safety of the lift and to be able to maximize off-site development to meet the demanding turnaround window.

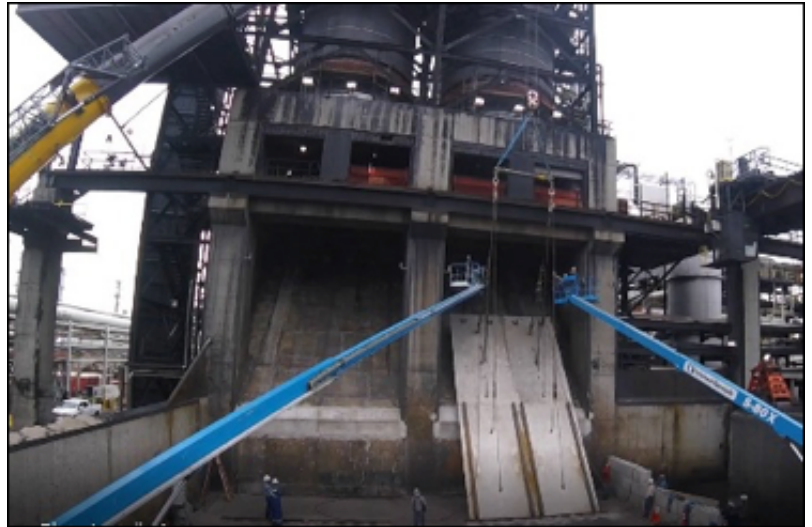
View of Wear Plate Being Installed

The analysis proved that the root cause of the problems was from two primary issues. First, the existing wear plate design was rigidly attached and didn't allow for thermal relief. Second, the materials of construction used previously were less appropriate for the operational conditions the materials were subjected to. The solution was to switch to a floating wear plate design to allow for thermal growth, alternative metallurgies for the wear plates and support system, and specialty concrete mixes for the chute repairs. To meet the schedule and logistical demands of the turnaround, the wear plate assembly had to be completely remote from the Coker then transported in and lifted into place. Brindley was awarded the International Concrete Repair Institute (ICRI) Award of Merit for the innovative approach.
