After any fire event, the concrete should always be evaluated thoroughly by trained experts

Post Fire Evaluation

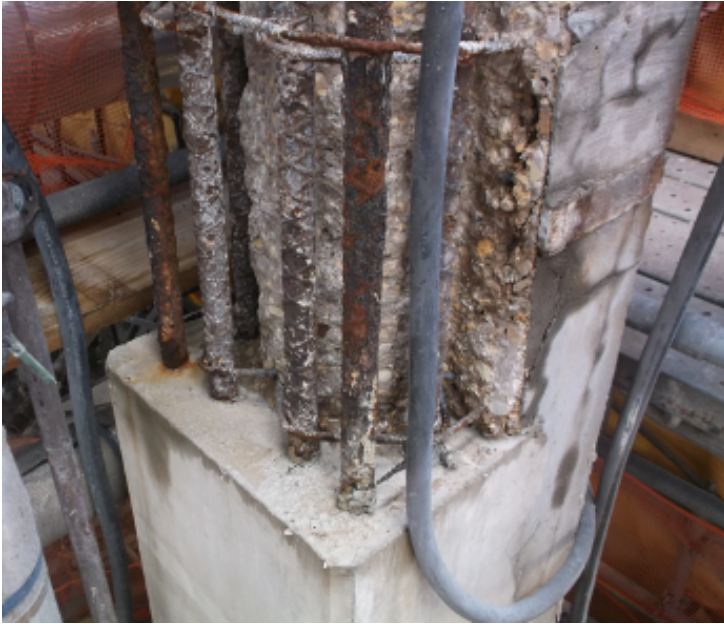
Reinforce Concrete Deterioration

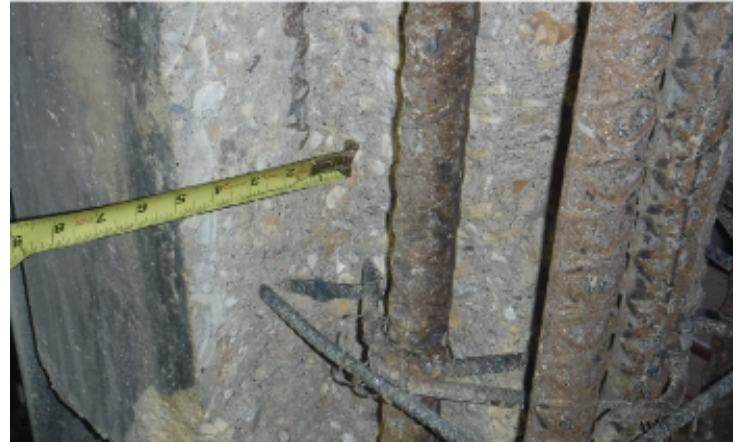
Reinforce Concrete Deterioration 5"

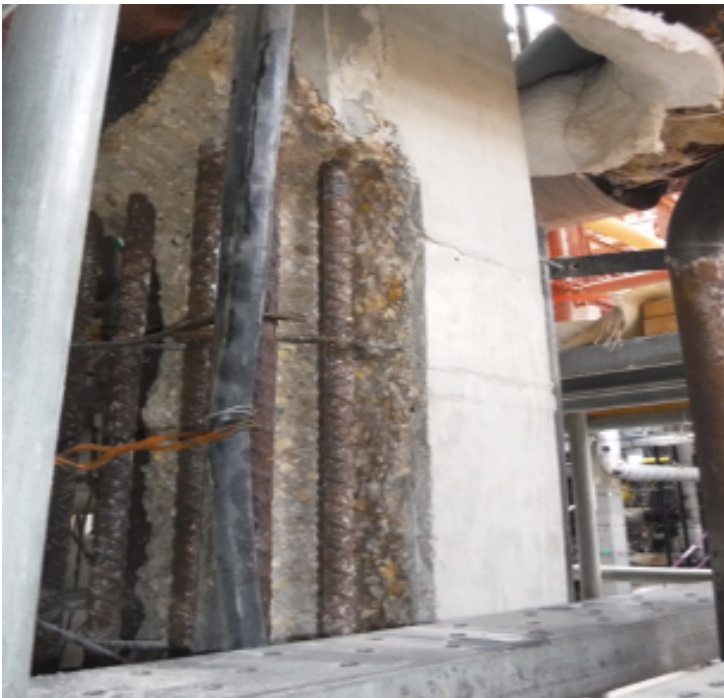
Partially concrete repair in progress

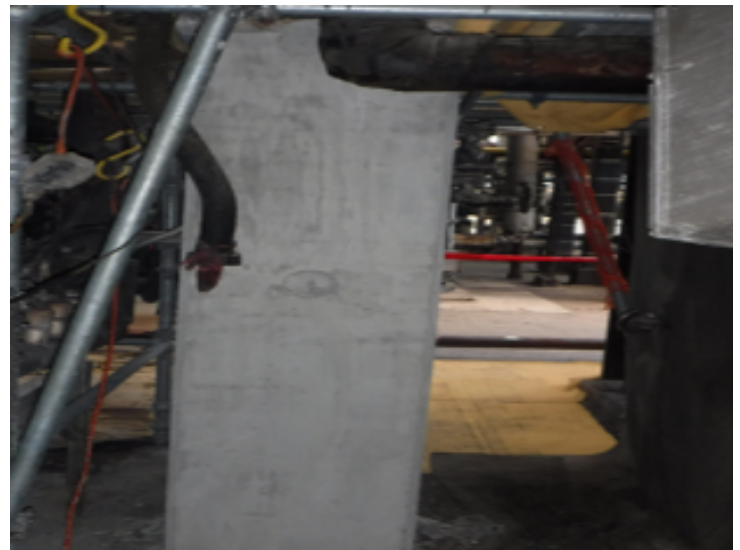
Full concrete repair completed
