Design & Implementation of Fin Fan Stiffening System

BE was consulted to provide a field evaluation, analysis, engineering, design and construction field technical services for the removal and replacement of multiple module roofs that also served as the floors and support structures for fin fans mounted to the floors. These modules were located at a facility in Prudhoe Bay, Alaska and the projects lasted over a multi-year period. Upon initial evaluation into the root cause of failure of the existing flooring systems, it was found that the existing fin fans were experiencing excessive vibrations and had been field mitigated previously by installing screw jacks from the fin fan motor structure to the concrete floor. These vibrations were largely caused by a combination of the dynamic forces caused by motor and gear box, which were mounted to a steel “sled” and supported vertically by a low-stiffness, thin sheet metal shroud. Understanding and implementing a solution to mitigate or divert these vibrations proved critical to providing a final product that had high constructability and was fit for service in this harsh environment.

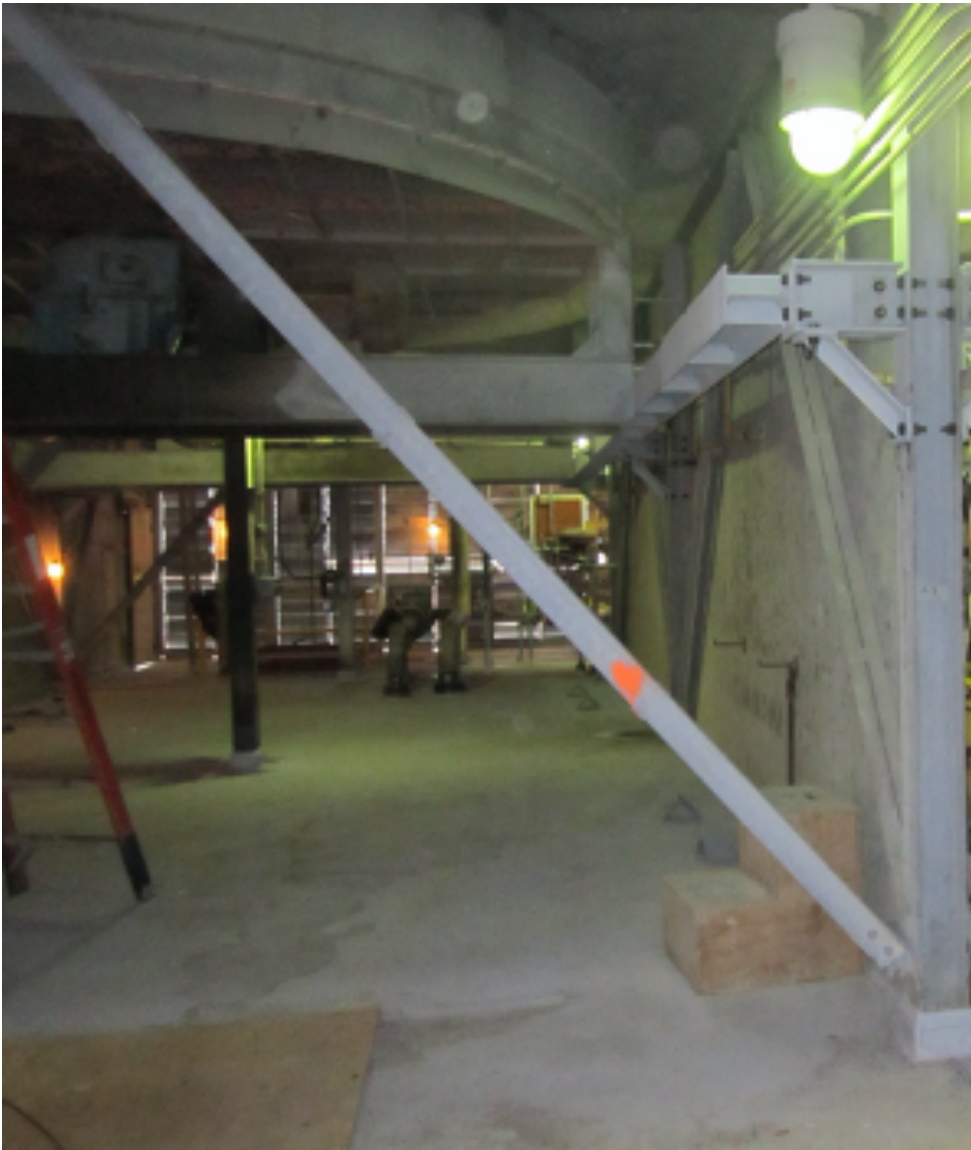
To redistribute the vibration forces, BE designed a stiffening system that tied the existing motor supports back into the structural steel columns around the perimeter of the floor, which support the superstructure above the fin fans. This stiffening system incorporated W8 structural members as lateral bracing, with webs horizontal, to provide stiffness in the direction of highest vibration, which was lateral. Great details such as all bolted and double-nutted slip-critical connections allowed for great constructability and improved reliability by greatly dissipating the vibration by stiffening the dynamic load through the steel system. The new fin fan stiffening systems, of which 13 have been installed, have proved effective over their first seven years of design life. Fin fan stiffening, although not part of the original fin fan floor replacement scope, proved to be a vital project addition to mitigate a root cause of failure, and thus, increase the next service life cycle of the fin fan floors.
