Part 4: Rewarding Careers in Structural Engineering: Structural Assessment & Collapse Mitigation

Reliability Project Case Study Analysis & Mitigation

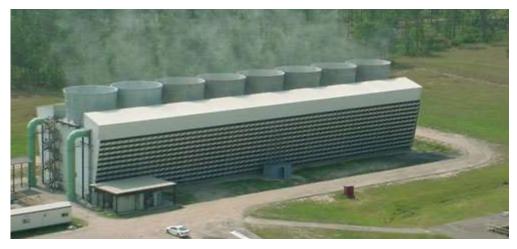
Industrial facilities often use heat to convert raw feedstocks into their final products, and cooling towers are vital to cool some of these process streams. Historically most cooling towers have been made of wood, but increasingly composite materials are becoming more popular for improved rot resistance.

Brindley Engineering recently was called to assess a large, 12-cell tower in Canada that experienced a partial structural collapse of two cells due to excessive ice-build up within the cells and a weakened support structure due to rot of the wood framing system caused from continuous wetting. Members from our Structural Team mobilized to site to quickly assess the structure, build RISA™ structural models of the framing system, and assess the utilization of the remaining members in their current, in-situ condition. To keep this vital piece of equipment in service, the team developed a two-part plan starting with temporary shoring to keep the structure stable until the weather improved, and permanent repairs for when the tower could be shut down during a plant-wide outage. The team had to contend with a dynamic situation and high loads from both the environment and 42" diameter water lines, making this a challenging structural engineering problem to solve.

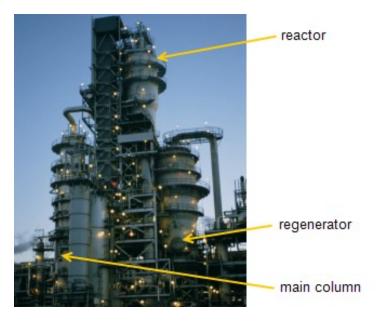
Example of FCC Unit

Fluid catalytic cracking (FCC) units in refineries are the units that produce gasoline and operate around 900° F. They are vertical units, with heights more than 200 ft, and the largest equipment is high up in the structure.

The center of mass and center of surface area for these units is towards the top of these structures, creating significant wind and seismic loads. Further, these units operate around 900° and the internal process equipment and piping can grow more than 6" vertically, creating challenges for structural engineering in supporting these excessive and moving loads.
