# **API 579 - Fitness for Service Assessment**

## Performing a Tank Fitness for Service Assessment

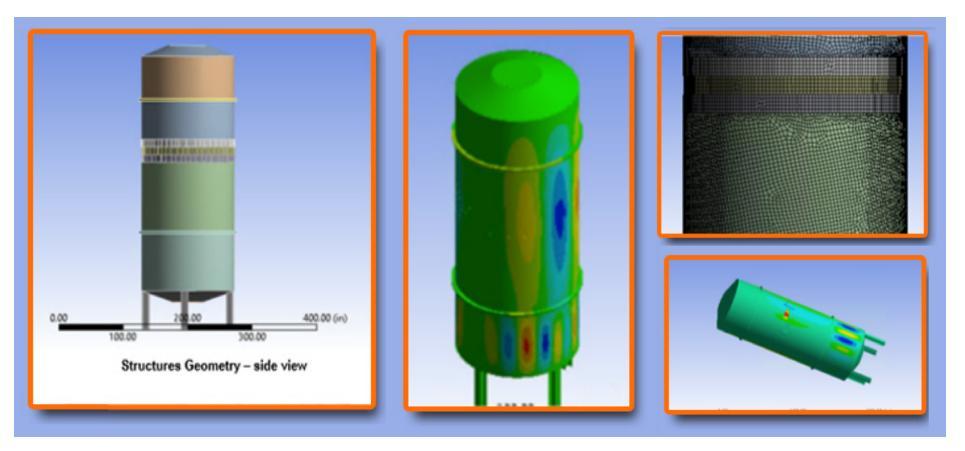
BE performed the Fitness for Service assessment on the tank to determine the structural serviceability and life span. Three-dimensional (3D) scanning utilizing high resolution scanning devices were used to obtain extremely precise measurements. Meshing software was then used to stitch the 3D images together to form a model which was then analyzed in ANSYS Finite Element software. This software analyzes the model for stresses in accordance with applicable codes. When completed, all code requirements were verified and the Fitness for Service (FFS) report was completed, including the anticipated performance under a multitude of environmental, mechanical, and structural scenarios.

Accessibility to the equipment was a substantial challenge in this engagement. Not only was this tank surrounded by an abundance of electrical conduit and piping, densely packed structural steel and platforms enveloped the immediate area. When scanning the tank, multiple scanner locations were required to achieve the full aspect and perspective of the equipment.
