## Investigate, Design, Manage Approach to Correct Gantry Crane Wheel Bearing Failures

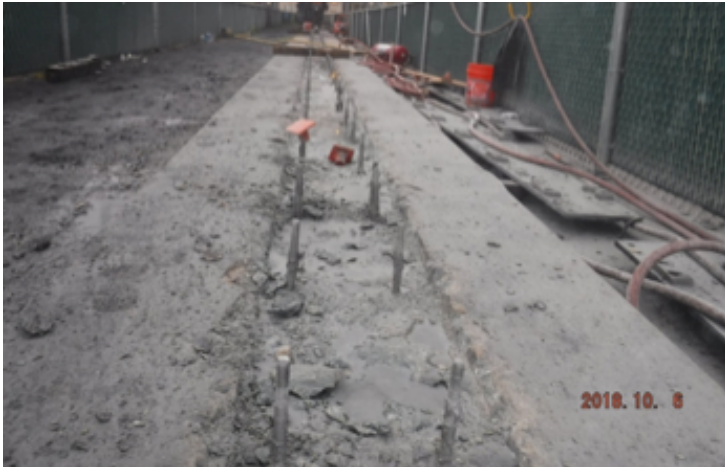
Typical View after Rail Removal

Special investigation techniques were used to determine the depth of coking oil ingress into the concrete, which is critical for scope determination, detailing, and construction execution. Bearing plate design with proper grout selection and installation details to avoid cracking and heaving ensure that the high point loads under the rails can be accommodated while resisting coke fine ingress and acid attack to ensure a long service life. Rail hold down supports need to be designed to accommodate the thermal loads, point loads, and horizontal loads imposed by the crane yet need to work with the bearing plate and grout design to ensure reliability. Specialized thermite welding of the rails is needed due to the materials of construction and to improve crane operations.

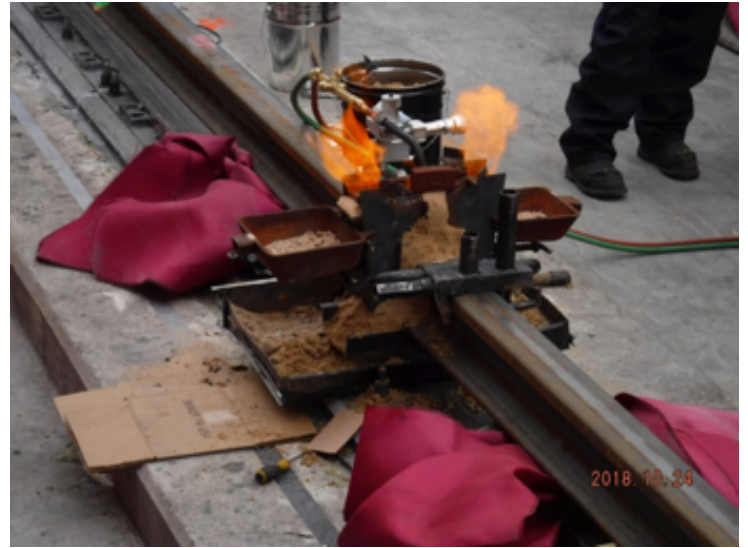
Thermite Welding

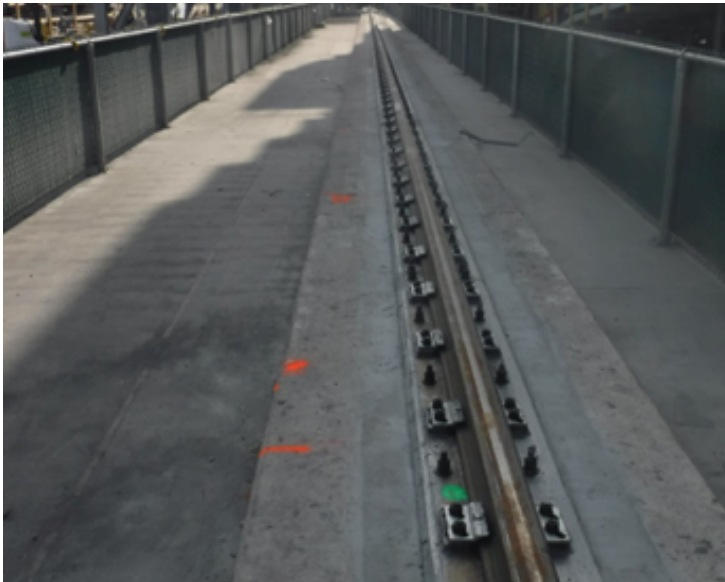
Example Completed Rail System
